2018 Data Report for

Lower Hamlin Lake, Mason County

Site ID: 530073

Lower Hamlin Lake, Mason County 2018 CLMP Results

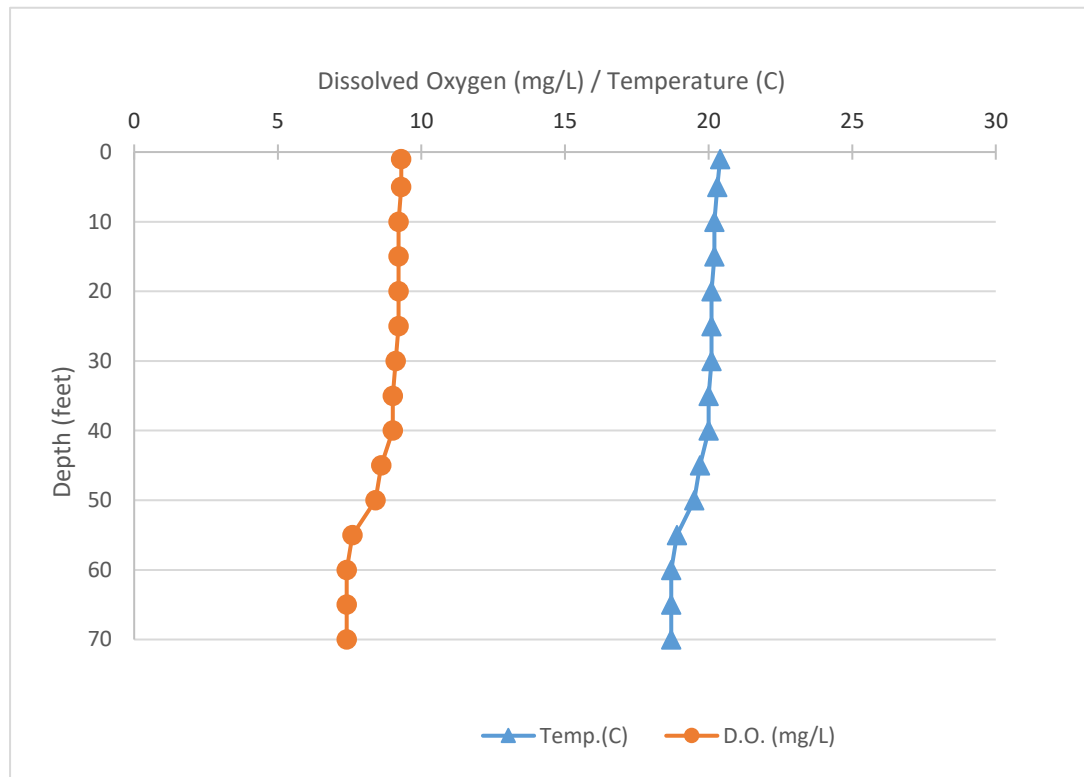
9/13/2018

Dissolved Oxygen and Temperature Profile

Depth (ft)	Temp.(C)	D.O. (mg/L)
1	20.4	9.3
5	20.3	9.3
10	20.2	9.2
15	20.2	9.2
20	20.1	9.2
25	20.1	9.2
30	20.1	9.1
35	20	9
40	20	9
45	19.7	8.6
50	19.5	8.4
55	18.9	7.6
60	18.7	7.4
65	18.7	7.4
70	18.7	7.4
